NASA Technical Memorandum TM 107554

Debris/Ice/TPS Assessment And Integrated Photographic Analysis For Shuttle Mission STS-52

December 1992

Gregory N. Katnik
NASA/Kennedy Space Center

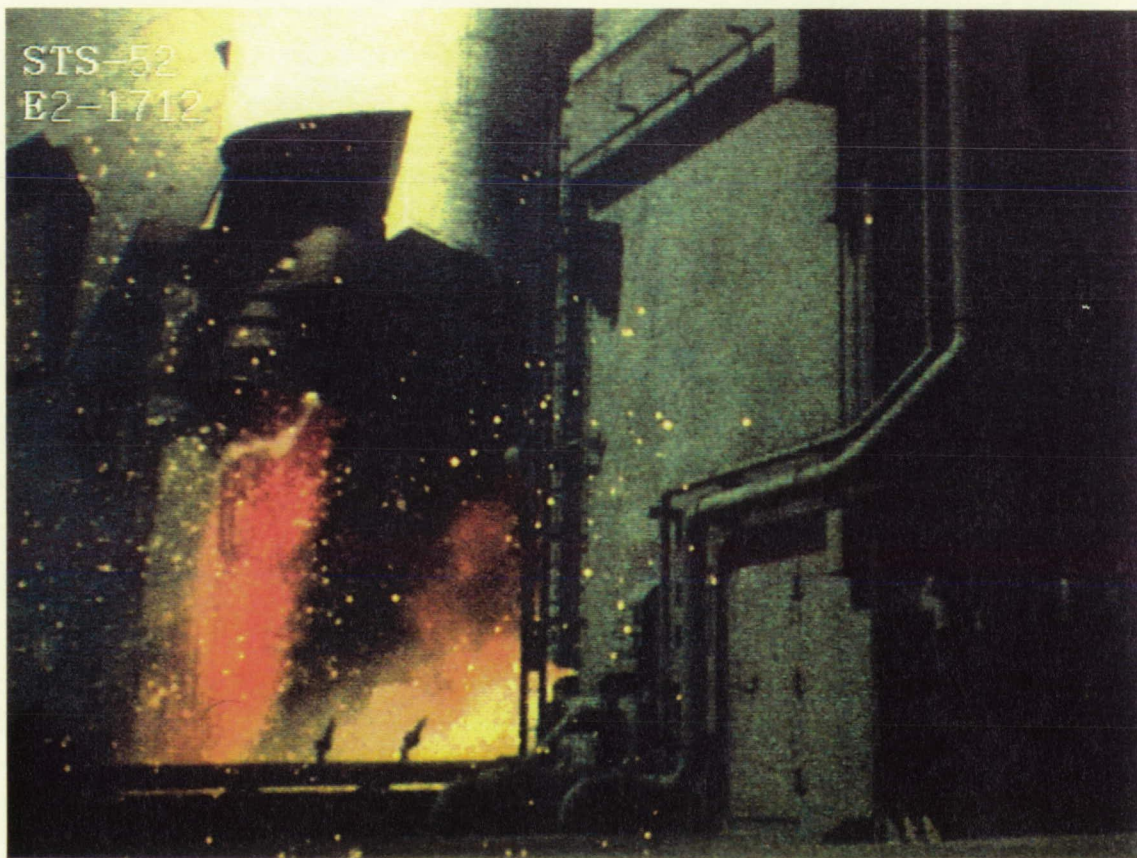
Orange vapor (possibly free-burning hydrogen) was noted beneath SSME #1 ~1.87 seconds prior to SSME #1 ignition (formation of mach diamond). (See Figure 2.2.1). Since free burning hydrogen is essentially colorless, engineers who reviewed films after the STS-38 mission believed that the orange cloud occurred due to impurities in the vapor. Similar events have been seen on twelve of the past nineteen missions. A comparison of this event with occurrences from earlier missions was performed. The amount and position of the vapor appeared similar to that seen on STS-35. See Appendix D Task #13 for analysis details.

Figure 2.2.1 Orange Vapor (Possibly Free-Burning Hydrogen) Noted under the SSME #1 Bell just prior to SSME Ignition

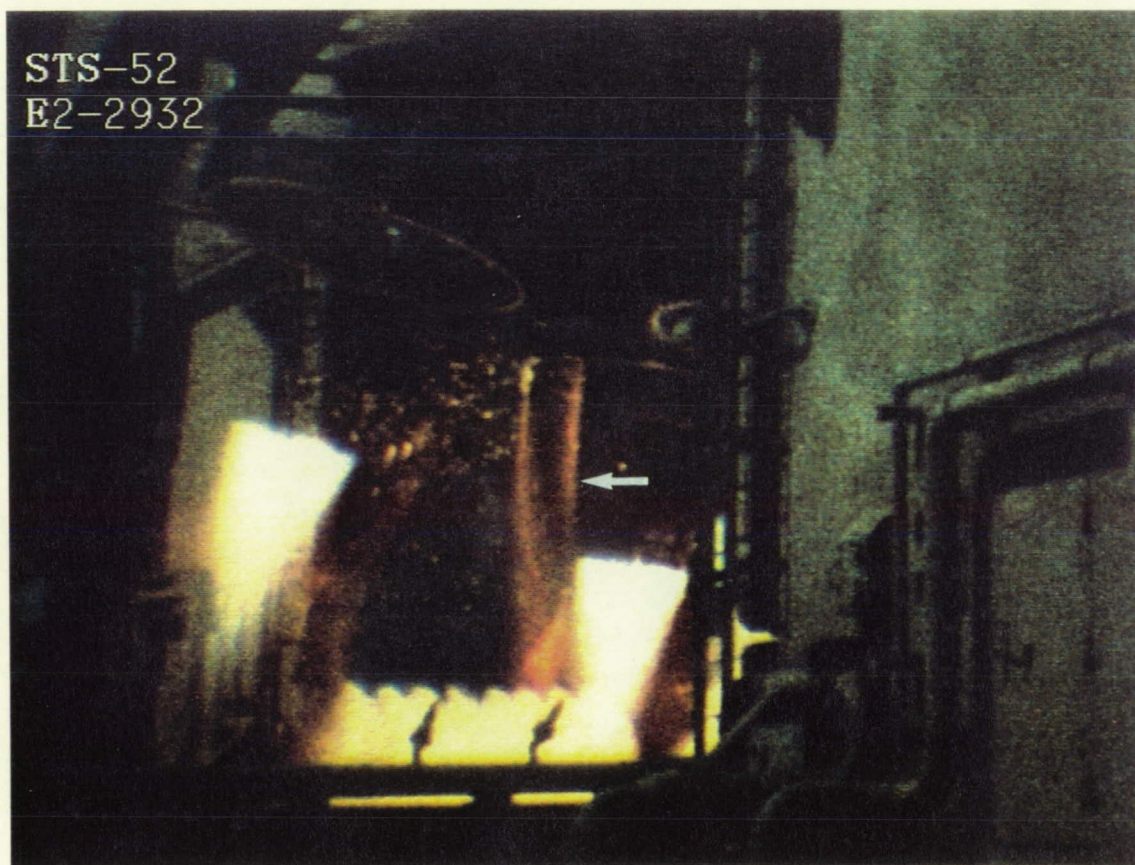
At least three orange/white flashes were noted in the SSME #1 and #2 plumes after ignition while the orbiter was still on the pad. The flashes in SSME #1 were timed at 296:17:09:36.356 UTC (T-2.658 seconds) and 296:17:09:39.252 UTC (T+0.238 seconds) as seen on Camera E-2. The flash in SSME #2 was timed at 296:17:09:37.128 UTC (T-1.886 seconds) on the same film. (See Figure 2.2.2). Flashes in the SSME plumes just after SSME ignition have been noted on ten of the past sixteen missions. While this event has not been considered anomalous in the past, future missions will be monitored for unusual occurrences or excessive numbers of flashes.

Figure 2.2.2 Flash in SSME #2 Plume 2 Seconds before Liftoff

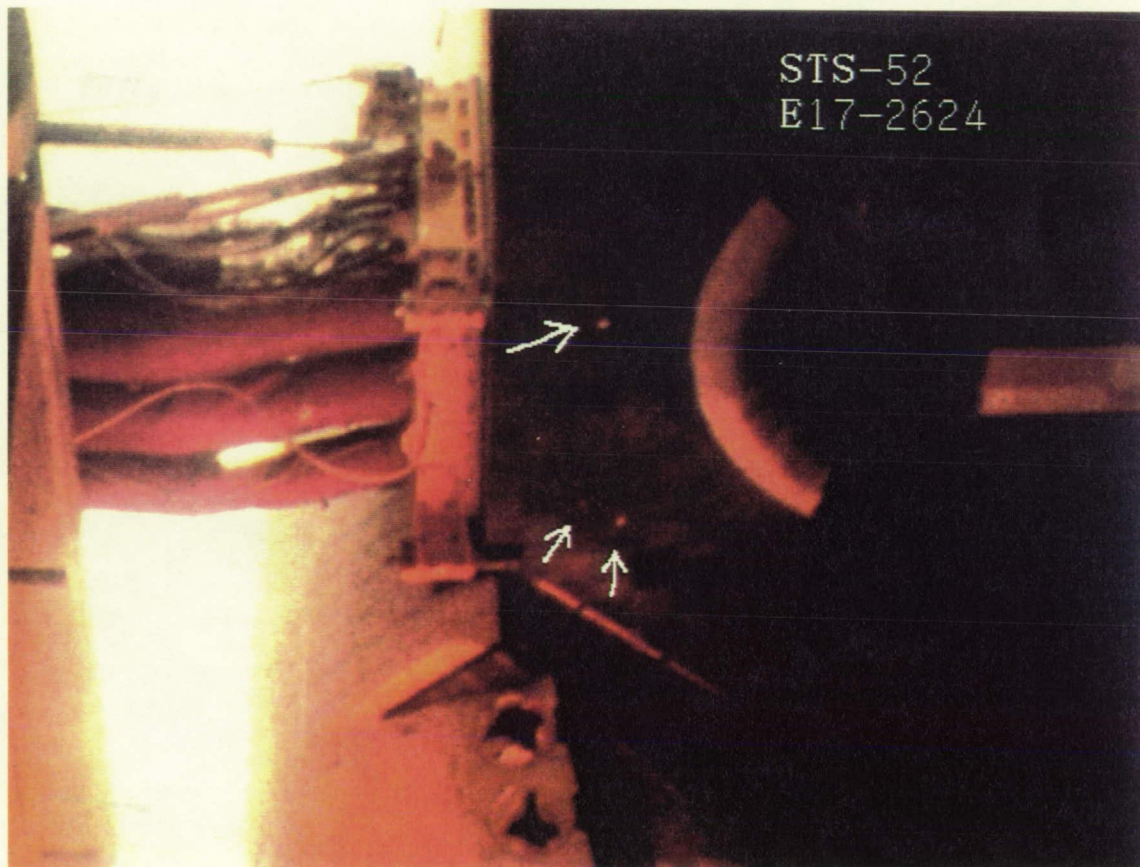
At least six occurrences of TPS erosion were noted at the base of SSME #2 and #3. (See Figure 2.2.3). Minor TPS erosion has been seen on nearly all previous missions. The erosion visible on this mission does not appear to be related to the tile damage noted at landing (see Section 2.5.2). No follow up action is expected.

Figure 2.2.3 TPS Erosion noted on Base Heat Shield

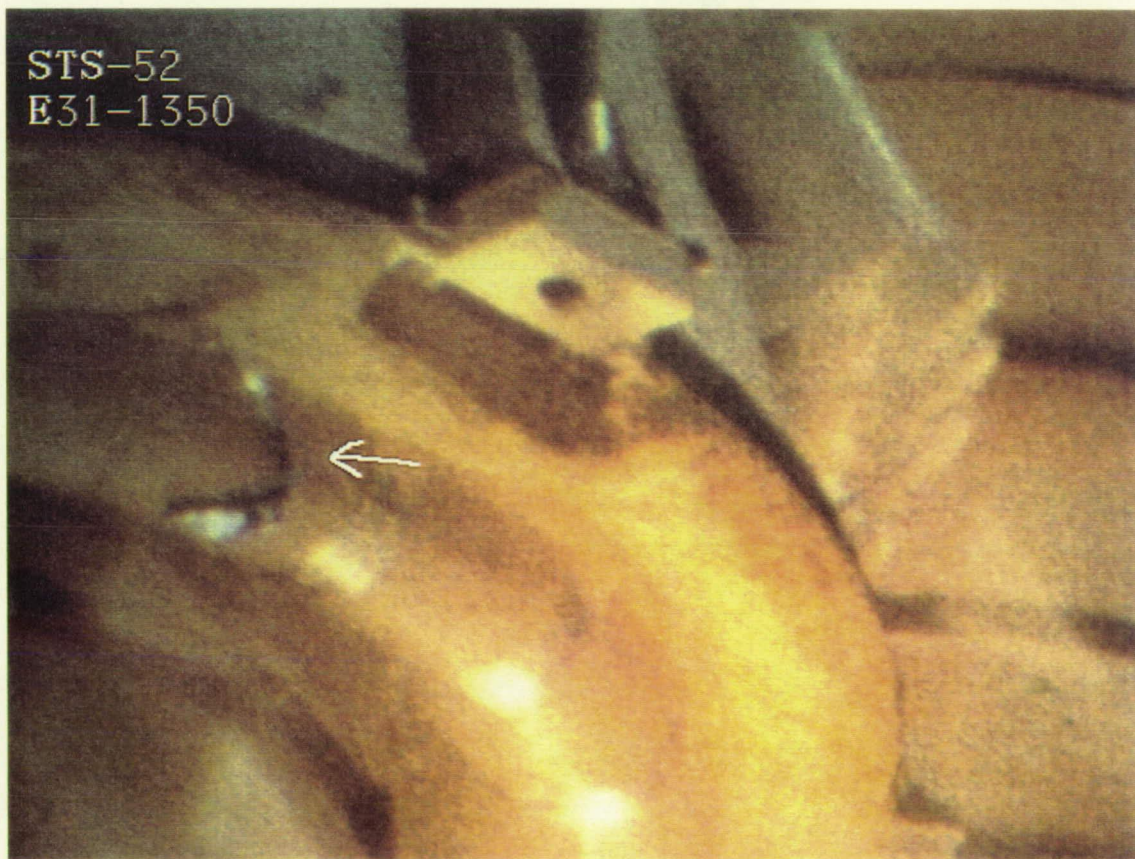
Loose tape was seen on both the LSRB and RSRB thermal curtains after liftoff. (See Figure 2.3.3). This event has now been seen on four missions since reflight. No further analysis is planned.

Figure 2.3.1 Loose Tape on LSRB Thermal Curtain

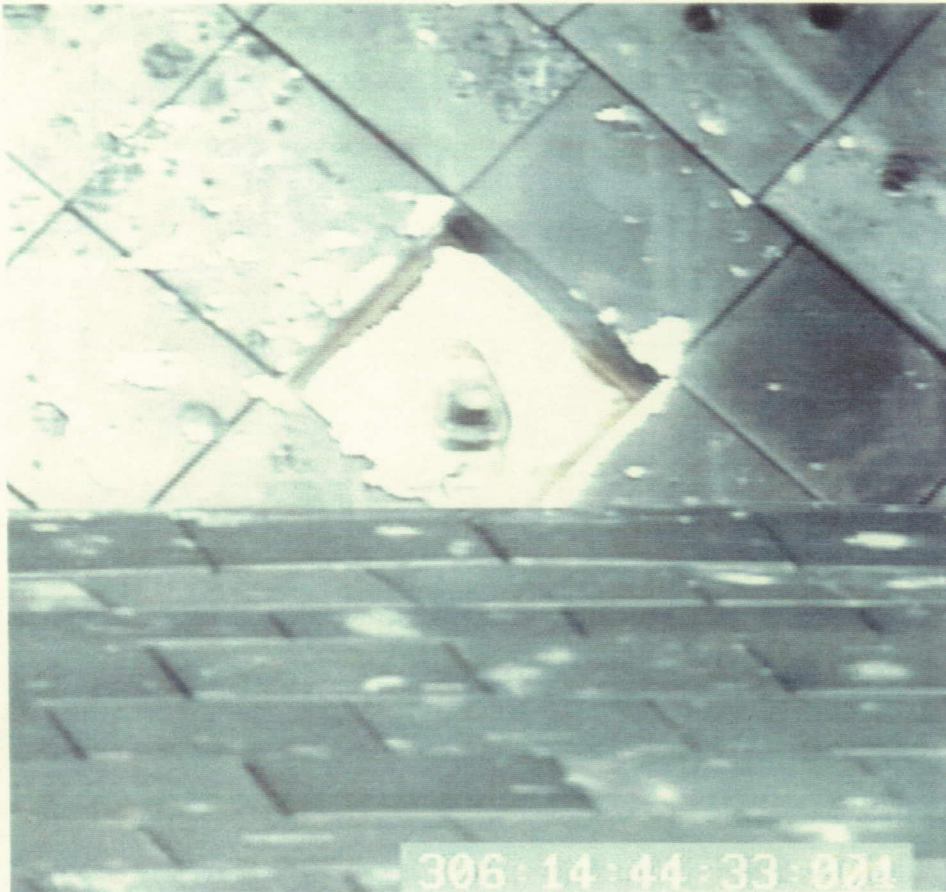
Figure 2.5.2 Damage to Base Heat Shield Tile seen during Post Landing Inspection
